# Buffalo Creek Watershed Assessment and Protection Plan

*(Washington County, PA and Brooke and Ohio Counties, WV)*

June 2005

Western Pennsylvania Conservancy  
Watershed Assistance Center  
246 South Walnut Street  
Blairsville, PA 15717

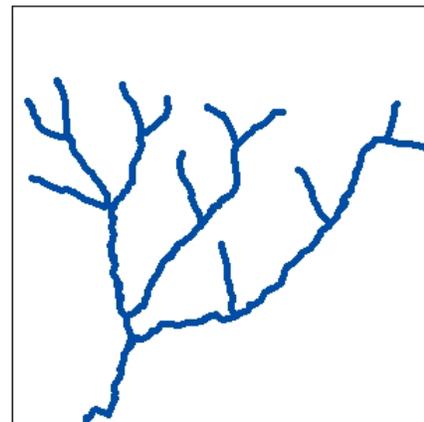
Drainage patterns are formed by the interactions between geology and topography within a landscape. Streams in Buffalo Creek primarily take on a dendritic drainage pattern, which closely resembles the branching of a tree if looked at from

*The dendritic drainage pattern of Dunkle Run subwatershed*

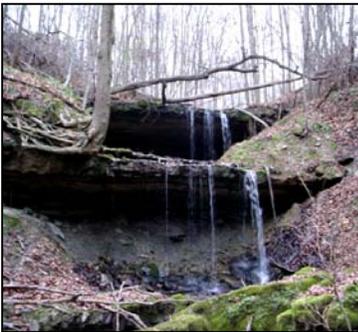
*The resistance of sandstone to erosion often results in small waterfalls such as this one along a tributary of Buffalo Creek*

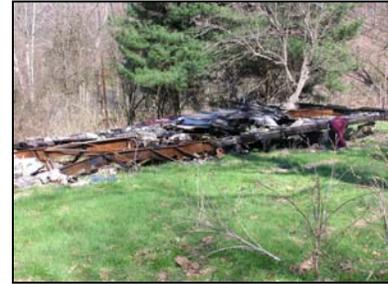
*An old trailer foundation and trash at Polecat Hollow*

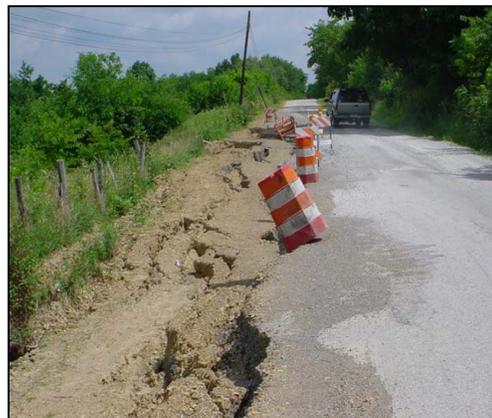
State routes include Routes 844, 331, and 221, which run east to west, and Route 231, running north to south. Large-vehicle traffic is limited because of small, one-lane bridges and road failures. Township roads, which often reflect the last names of residents or key features, are found primarily along stream courses. As with state roads, large storms often cause road failures and dangerous conditions.

***Road failure in Donegal Township***

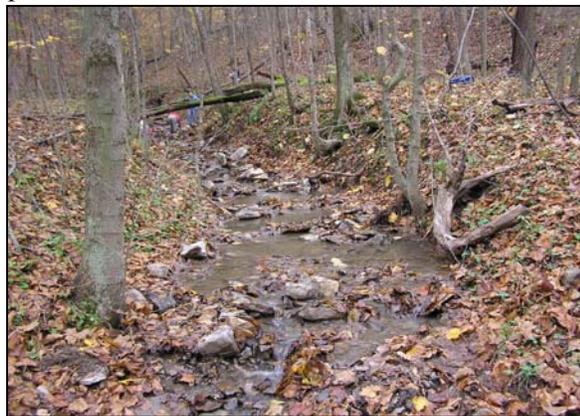
*The riparian zone along Narigan Run provides important filtering functions and supports salamander populations*

**Riparian zones** are vegetated buffers along streams, rivers, and lakes that filter runoff and provide a transition zone between water and land. A functioning riparian zone can reduce flooding by retaining water in its vegetation and soil. This also promotes retention of groundwater during dry periods. Vegetated riparian zones prevent soil loss and bank failures by holding soil in plant roots. They also provide important corridors for wildlife, enhance recreational activities, and provide fish habitat. Studies

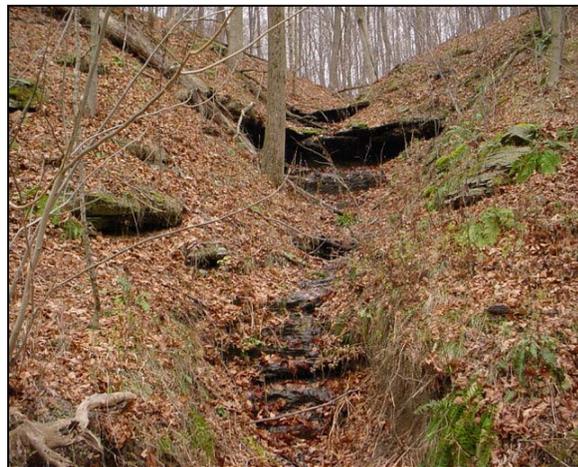
*Hillside seep entering a tributary of Buffalo Creek*

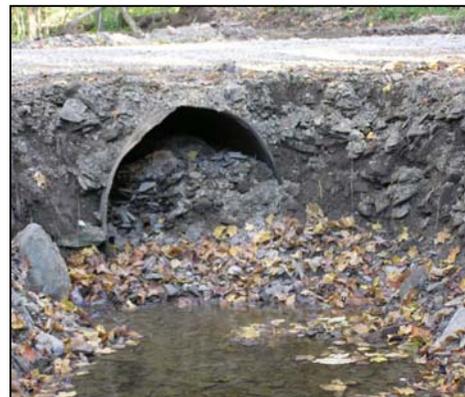
*An inadequately designed culvert and endwall from a Buck Run tributary filled with sediment after a flood in 2004.*

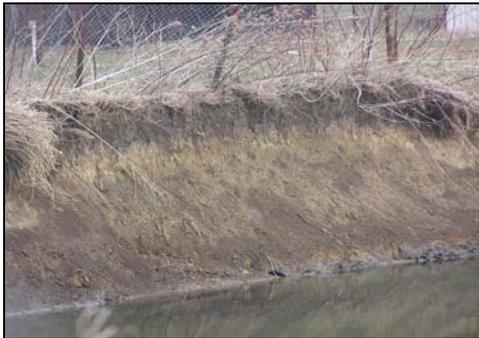
***Severe erosion along a section of Buffalo Creek, resulting in significant loss of streambank each year***

The visual assessment suggests that the biggest contributors of sediment to streams within the watershed are bank erosion from cattle access to streams and steep slopes and the removal of riparian zones. In the tributaries to Brush Run and Dunkle Run, extensive streambank fencing and use of best management practices are decreasing sediment loads. However, there are portions of the watershed where these practices are lacking. This is particularly noticeable in the Buffalo Creek East and Castleman Run subwatersheds, which are highly agricultural. There are many programs offered by the United States Department of Agriculture and other agencies that can help farmers develop best management practices on their properties. One such program is the Conservation Reserve Enhancement Program, which pays farmers to keep marginal land, such as streamsid es and steep slopes, out of production. Many

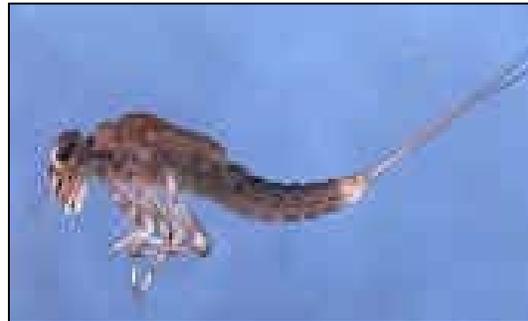
**This mayfly of the family Baetidae has a streamlined shape designed for maneuvering in running waters. (photo courtesy New York State Department of Environmental Conservation)**
